**St John Sharow**  
**Diocese of West Yorkshire and the Dales**

Condition report on stained and painted glass  
and leaded glazing

© Jonathan and Ruth Cooke  
January 2015

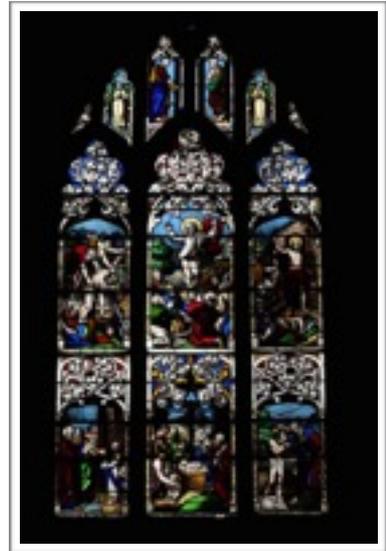
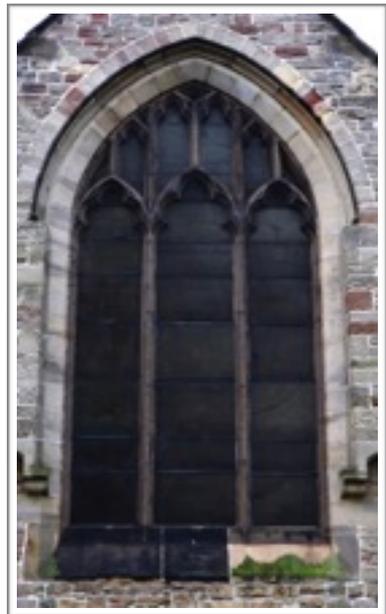
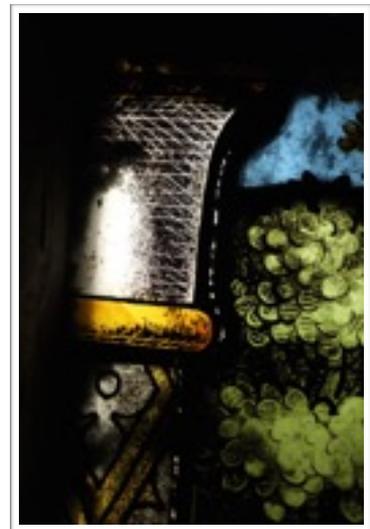
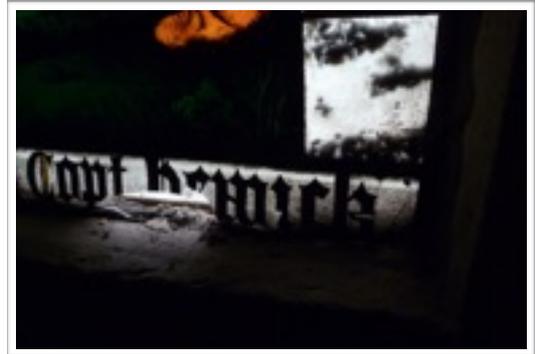
As noted above, the window was moved in 1873, and the convex lead profile suggests a further later intervention in the form of releading. However, no replacement glass was noted. The condition of the lead matrix is reasonable. No significant movement was noted within the accessed panels on slight pressure. Ties are all holding at present. Beyond the scope of this report, there is movement of this wall, which has resulted in *c* light in the separation of lead from glass, and lead from masonry, notably on the mullion side, where daylight is visible between glass and lead on the decorated pillar work, along a vertical line of weakness. See masonry, below. Leaded light cement is failing: lost in places, and otherwise of a powdery consistency. Lower parts of tracery panels were accessed, and are also in reasonable condition, as main lights.

Saddle bars Most appear to be mild steel: there is surface corrosion – no damage to stone from corrosion and expansion was noted.

Glass and pigments there are numerous single and multiple fractured pieces throughout, with a concentration of breakage in the pillars at the outer edges of the panels. The damage appears to have been caused by pressure, given the movement in the wall and the hard mortar mix noted above. Three

holed pieces were noted: part of the inscription at base of *b* light, a piece of white glass yellow stained foliar canopy below spring in *c* light and a further piece of stained and heavily stippled white glass in *a* light, where a putty repair has been effected.

Dirt and deposits In common with other windows in the church, there is a fine layer of loose dust and cobwebs on the interior surface, and more thickly adhering grime and bar deposits. The external glazing is fractured and holed in places, permitting water ingress. The accumulated debris of stonedust, organic deposits etc. is detrimental to the painted glass, especially to backpainting. The holes<sup>9</sup> and fractures will allow water ingress and further build up of deposits. Additionally, the fractures and dirt build up in the interspace visibly intrude through the painted glass in places as disfiguring dark lines and patches, and the holes create unintended bright spots.

Masonry As noted above, there is movement in the wall. The mortar is a hard cementitious mix, and has been a contributory factor in the breakage to the glass. Movement in masonry is causing mortar failure around bar sockets. External inspection shows that the original wire guards, recessed into the jambs and mullions of each light, have failed and have been replaced by single sheets of mesh, obscuring the fenestration and screwed into the nose of the mullions with what appear to be ferrous screws.

**Recommendations** The clarity of this window of national and, arguably international significance, is obscured by various kinds of deposit. On the internal face are bar deposits and cobwebs: the deposits are mainly on the external face of the painted glass i.e. in the interspace between painted glass and external glazing.

Removal of the wire guard and refixing with non-ferrous fastenings is desirable in the interests of the masonry; new stainless steel guards fitted within the sight size openings would be preferred. However, if the external glazing which diffuses light and minimises the impact of external mesh, were removed, the mesh could be visually disturbing, as the window is viewed.

The external glazing, while the cause of the problem of deposits, has also provided through the years an element of protection for the lead and glass against wind pressure. If it were to be removed, for cleaning or other purposes without replacement, the prospect of having to intervene further rather sooner than otherwise must be contemplated. Any replacement should be ventilated to minimise future problems. One controversial but perhaps acceptable short – medium term measure would be the installation of ventilated polycarbonate sheeting. However, as noted above, removal of the amber glass would substantially alter the colour of the window. There are additionally other potential risks such as the through bar at spring, and movement within the wall. We would therefore recommend careful planning before any intervention, to ensure the best long term outcome for this window.

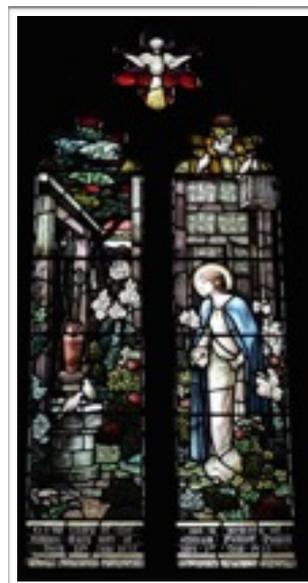
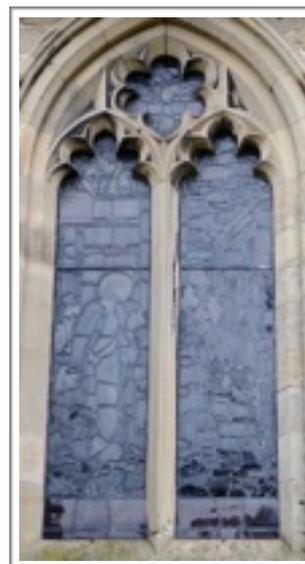
Lead matrix	Reasonable. All elements sound.
Saddle bars	mild steel. There is little surface corrosion. However, the mullion is delaminating severely both internally and externally. At fourth bar from cill on <i>a</i> light, mullion side, the shape of the damage to masonry may indicate corroded metal in the bar socket, and there are patch putty repairs to the mullion in this area.
Glass and pigments	All as original. No later interventions noted. One single fractured piece with two breaks in head of <i>b</i> light and a single break in <i>2a</i> mullion side: both due to pressure and not recent. Painted pigments well fired and apparently sound.
Deposits	Internally, loose dust and cobwebs.
Recommendations	<b>Stonemason's report on condition of mullion. Conservation clean.</b>

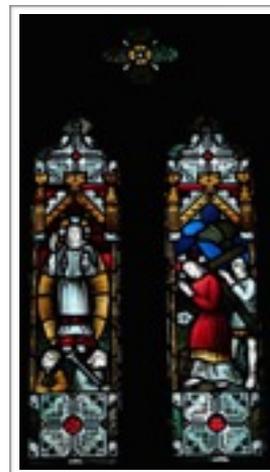
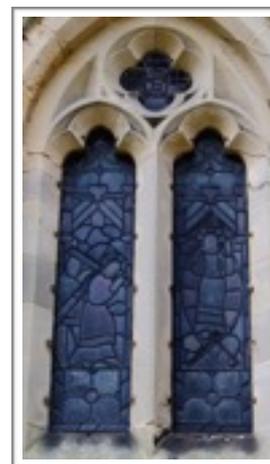
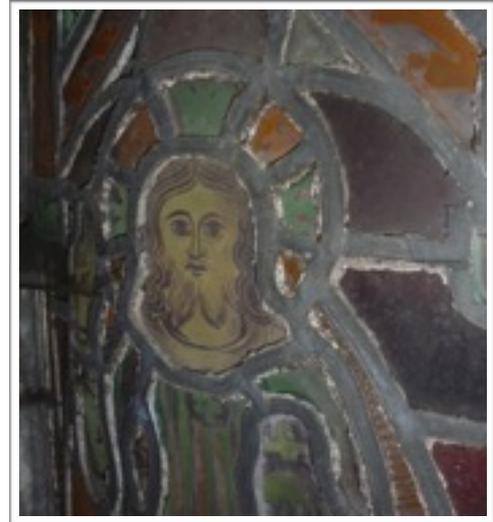
Lead matrix	No interventions noted. Leads oxidised and stretched. This window has suffered from solar heat softening the leads, resulting in distortion of the panels. In 1996 the present writers observed:
-------------	--

In the intervening 20 years, the condition of this window has not significantly deteriorated, despite its alarming appearance. There is substantial distortion, particular in *a* light, to a depth of approximately 25mm, and daylight is visible between glass and lead in places. Despite this, only a single pressure fracture was noted in *b* light.

Leaded light cement is failing, with a 'frilly' appearance in places, indicating past condensation settlement.

**Glass and pigments** There is some evidence of past water damage to painted pigments where condensation has collected and settled along lead lines. Pigments should therefore be assumed unstable.

**Wire guard** The window was previously protected by mild steel guards, of which only the tracery quatrefoil remains. The guards to the main lights have been removed, leaving the ferrous metal fastenings (into wooden plugs) which have stained the masonry.

**Recommendations** **Monitor structural condition for signs of further distortion. Remove wire guard fixings and patch point to make good. Conservation clean interior glass surface.**

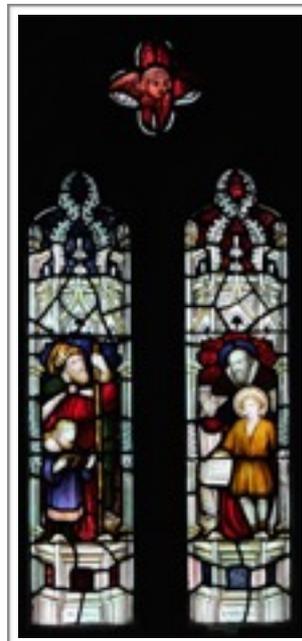
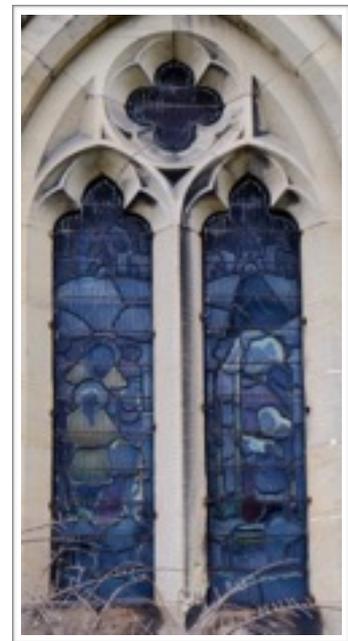
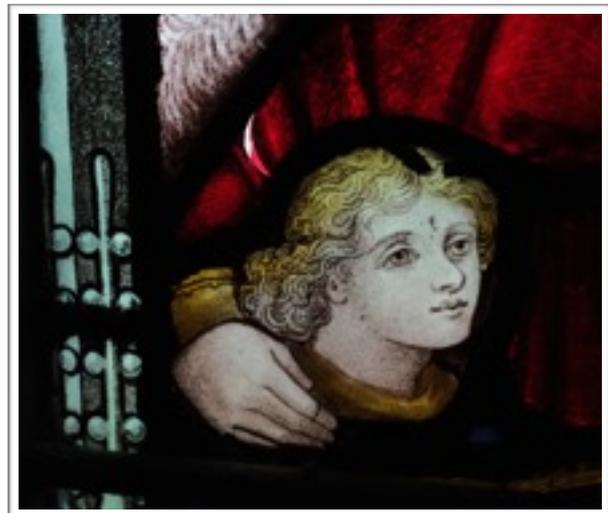
#### sIV south chapel south

**Lead matrix** reasonable. No interventions noted. This window has suffered from solar heat softening the leads, resulting in distortion, notably in *a* light along a line of Eli's staff, which is a design weakness. An associated tie on the centre bar is broken. A single fracture has opened up on the ruby flash forming the robe on Eli's right shoulder. No interventions noted.

**Glass and pigments** Single fracture noted, as above, due to pressure. Pigments apparently stable throughout.

**Wire guard** As sIII, but corroded wire guards to main lights as well as tracery remain in place. These are probably not effective other than as a visual deterrent, and are staining the masonry

**Recommendations** **Monitor structural condition for signs of further distortion. Remove wire guards including fixings and patch point to make good. Conservation clean interior glass surface.**

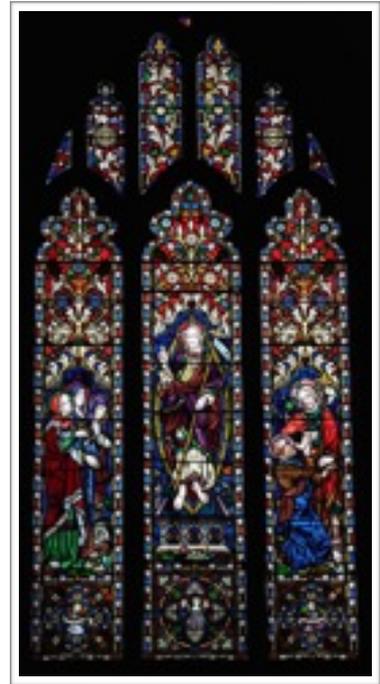
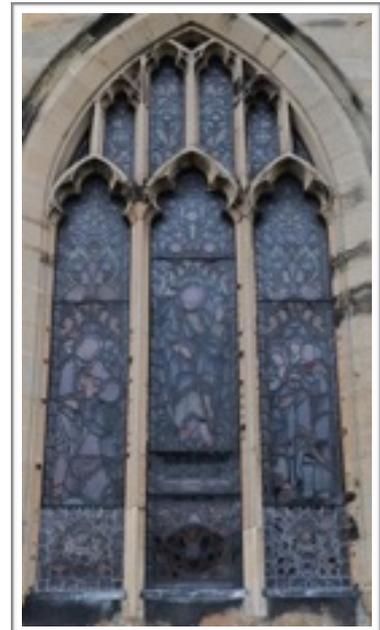
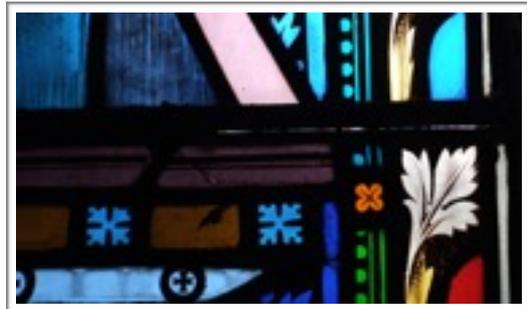
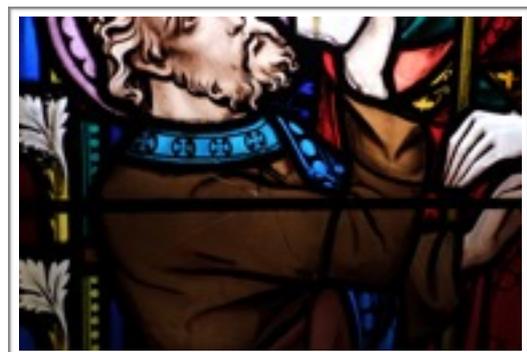
Structurally weak. Panels *1a* and *1c* have been removed since original installation; *1a* has been partially releaded, possibly due to excessive distortion. This window suffers from solar heat softening the leads, resulting in distortion; most panels are affected. The distortion follows lines of weakness in the lead net. *b* light appear to be the worst affected. As noted above, *4b*, the top panel in this light, is only tied at the lower division. The structural weaknesses are aggravated by overlapped panels, on divisions between *1* and *2a*, *b* and *c*. The upper and lower divisions of panel *3b* are no longer correctly seated and daylight is visible on both divisions. The distortion of the panels immediately beneath appears to have allowed *3b* to drop slightly under its own weight. All ties are holding for the present. Leaded light cement is failing throughout.

Much breakage throughout caused by pressure. There is an area of damage involving two or three adjacent pieces caused by external impact around the shoulder and collar of Thomas's tunic in *2c*. Fragments are not entirely secure within the leads.

Evidence of past condensation which has settled on lead lines: in general, the more heavily painted pieces are the more damaged, pigments are lost in places, which may indicate instability on underfired glass. Pigments should therefore be assumed unstable throughout.

Externally, the condition of the upper part of the mullion between *a* and *b* lights is very poor. The base of each mullion has been replaced. As sIII, the ferrous fixings from guards, now removed, remain in the masonry. It would appear that some of the damage to the mullion could be associated with corroding remnants of mild steel fixings.

**Recommendations      Monitor condition for any signs of further deterioration. Temporary securing of damaged area in 2c *in situ*, possibly by means of silicone on reverse and face. In the medium term, this window will require restoration, including releading.**

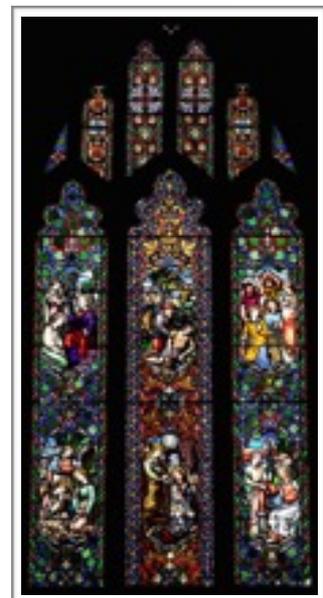
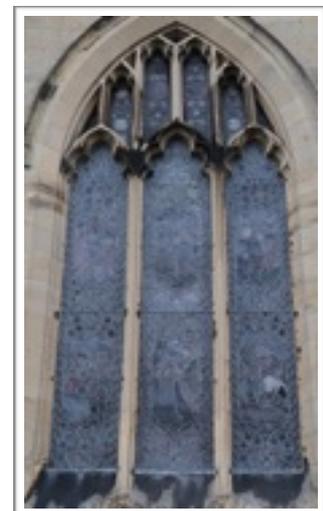
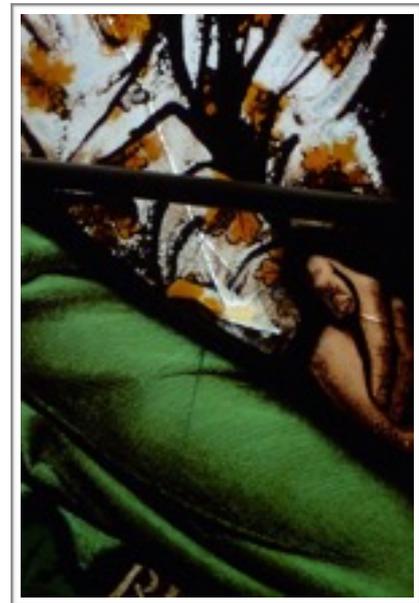
**Lead matrix** Main lights sound: recently releaded. Traceries not closely accessed: some distortion and could be becoming weak. In common with the other south wall windows, this window suffers from solar heat softening the leads, resulting in distortion. The design is heavy, the panels are large, and cartouches containing the subjects represent weaknesses in design; the distortion follows lines of weakness in the lead net.

**Glass and pigments** Some breakage throughout caused by pressure, now consolidated. Two external plates. Several holed pieces were noted in *2b*, and a further one in each of *1b* and *2a* caused by external impact, possibly chippings from grass cutting. Fragments are reasonably secure within the leads.

Evidence of past condensation which has settled on lead lines: in general, the more heavily painted pieces are the more damaged, pigments are lost in places. Pigments should therefore be assumed unstable throughout.

**Masonry** The ferrous fixings from guards have been removed from main lights, but remain in the tracery lights.

**Recommendations** **Conservation clean, including tracery lights. Access for cleaning would provide the opportunity for more detailed inspection of structural condition of tracery panels.**

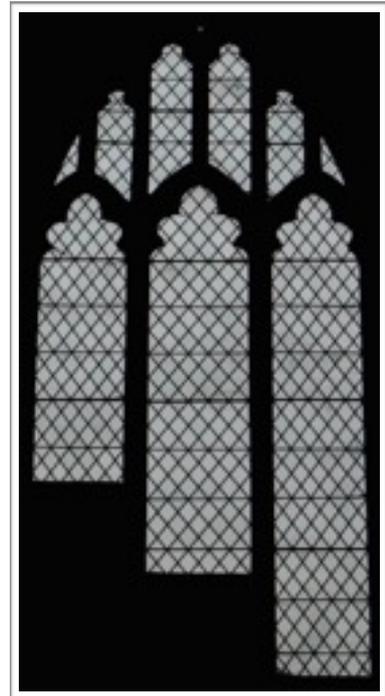
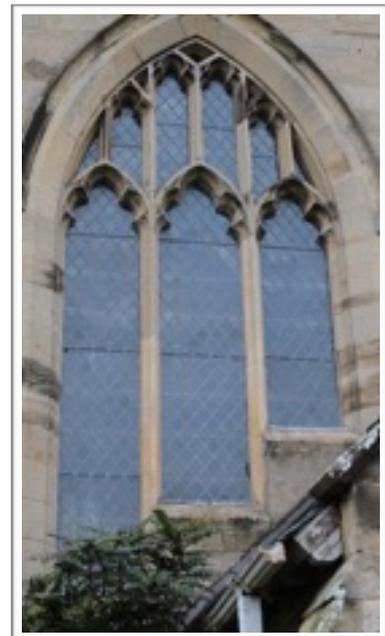
Condition	structurally sound. Dust, cobwebs and patchy microbial growth is visible on the internal surface. There is a single fracture in each of 1 <i>b</i> and 1 <i>c</i> : two fractured pieces in 3 <i>c</i> and a holed piece in 2 <i>c</i> .
-----------	--

Recommendations	<b>Conservation clean, consolidation of broken pieces. <i>In situ</i> repair to holed piece.</b>
-----------------	--

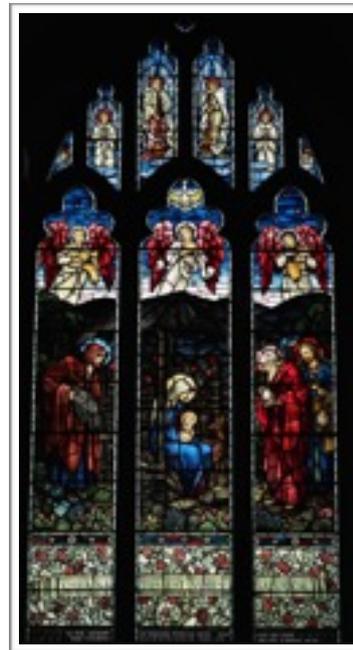
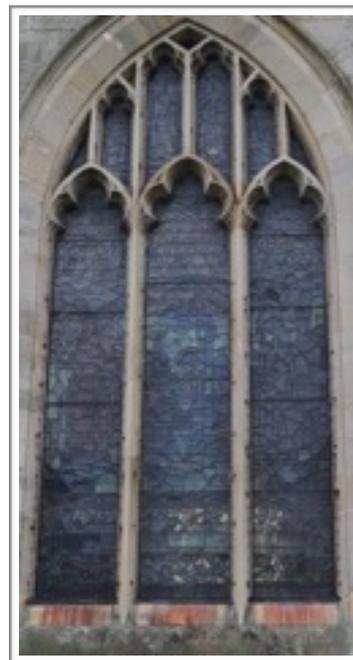
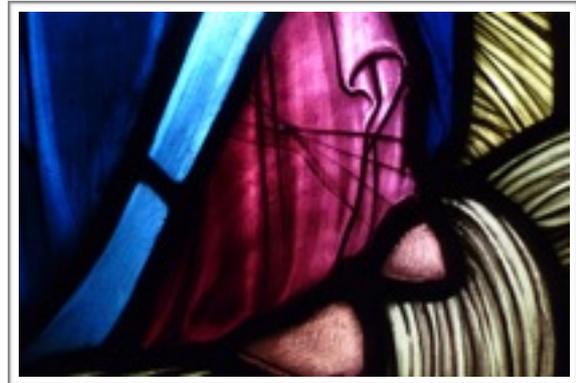
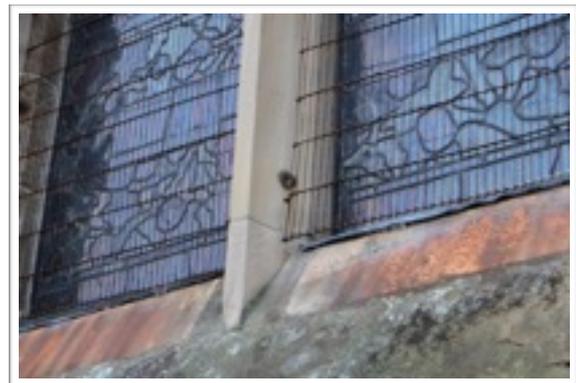
## nV nave north wall westernmost

Glass and pigments              minor breakage to two of the nimbi in 3c, probably due to pressure. Minor impact damage, not recent, to the purple robe in 2b, a single multi-fractured piece which is for the moment secure within the leads. Painted pigments apparently stable throughout where accessed.

Masonry and Wire guards              Woven mild steel guard, beginning to corrode and staining masonry at cill, probably contemporary with the window, with wooden plugs. These are now beginning to fail. Some staining to masonry from corroding metal fastenings.

**Recommendations              as a minimum, resecure wire guards at base of three lights. Preferred, replace with new stainless steel powder coated guards. Conservation clean.**

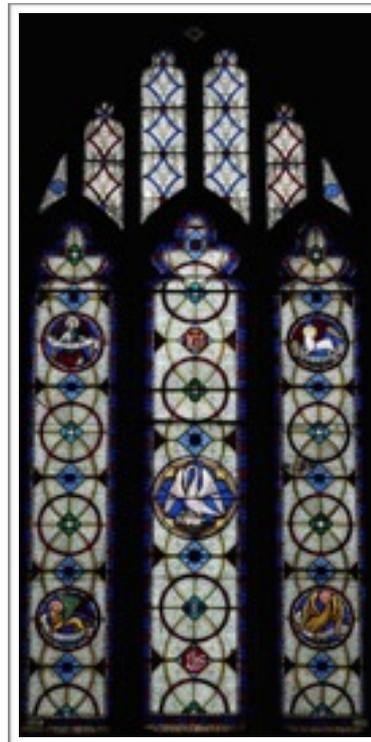
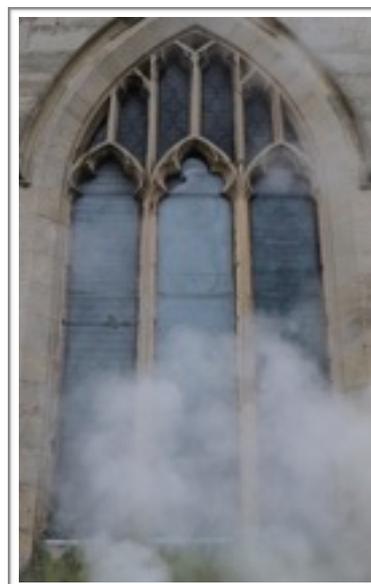
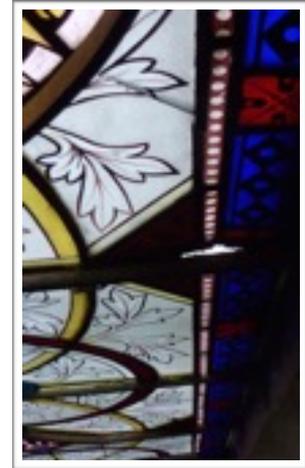
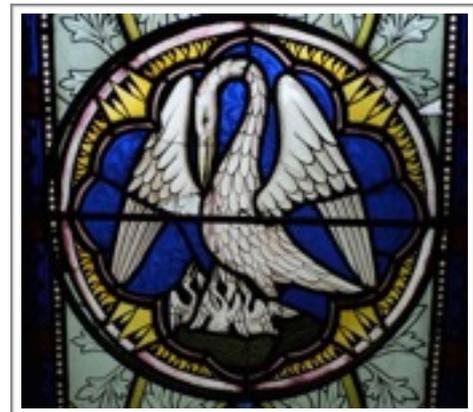
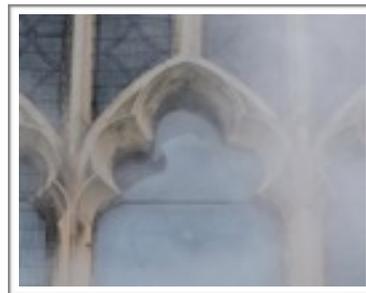
#### nIV nave south wall first from east

Structurally very weak, particularly the central section of *b* light, where there is excessive movement on even gentle pressure. Apart from a single cold painted repair to the right wing of the pelican figure, no later interventions were noted to the stained and painted panels. The external glazing to this window may have been a response to structural failure, as this is the only window thus protected.

The window is arguably underbarred. Moreover, although most ties are holding, they are insufficient in number: the pelican roundel is tied only to the upper quadrant of the circular frame, which is coming apart. Daylight is visible at first division from cill on *b* light, and elsewhere in places where lead and glass are separating. There is slight visible distortion of some panels in the main lights; this belies the degree of deterioration of the leaded structure. There is also distortion to tracery A3 which was not closely accessed. The ties at spring on *a* light have all failed. Leaded light cement is failing throughout.

Breakage throughout of varying dates caused by structural failure. Fragments are not all entirely secure within the leads, and there is a holed piece of grisaille in *2b*.

The external sheet glazing to the head of *b* light is broken, and represents a risk of injury. On *c* light, the mortar of the external glazing has failed. The western mullion is in very poor condition; there is a fracture running up the nose, and further fracture on the side. The recently installed boiler is producing volumes of warm damp air in the vicinity of the window, and the masonry is green at cill. Guards remain on *a* and *c* lights and four large traceries. That to *b* light is lost. Ferrous fixings remain in the masonry and there is some rust staining.

**Recommendations** **Removal of broken external glazing as a matter of urgency. This will necessitate immediate removal of the stained and painted glass of the main lights for remedial work. Restoration/releading of at least all three main lights, and probably tracery lights.**  
**Stonemason's report and masonry repairs**

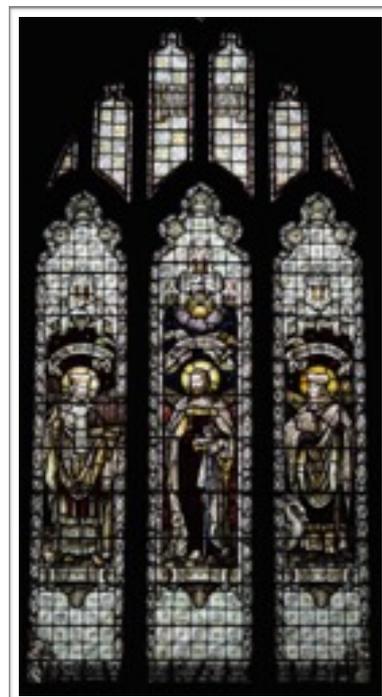
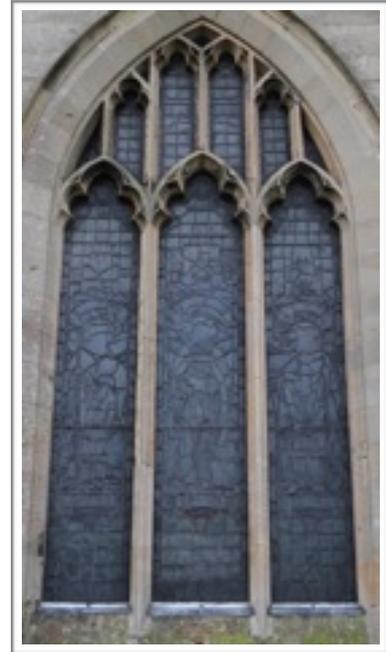
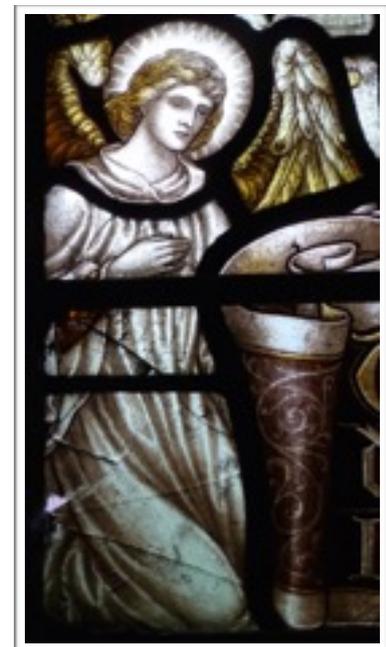
### nIII nave north easternmost

Glass and pigments Two damaged areas were noted: one including holed piece at jamb base of *a* light: one to St Cuthbert's scroll, where a single piece is multifracted, probably due to external impact. all fragments appear reasonably secure within the leads for the moment.

Masonry Remnants of guard fixings in masonry. Some replacement masonry.

**Recommendations** **Conservation clean: consolidation of broken glass *in situ***

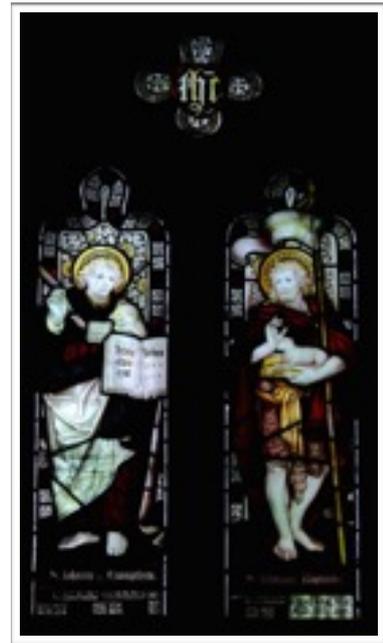
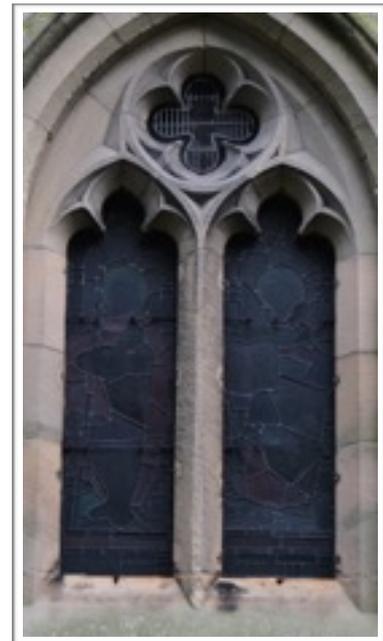
**wI tower base, west window**

Saddle bars corroded – now lost

Dirt and deposits Loose dust and cobwebs; some microbial growth on painted surface. Very dirty.

Wire guard Tracery corroded wire guard *in situ*. Remnants of wooden plugs/ metal fastenings remain in stone, which is stained.

**Recommendations** **Conservation clean. Introduction of new non-ferrous bars *in situ* in original positions, reusing ties where possible.**
