**St John Sharow**  
**Diocese of West Yorkshire and the Dales**

Condition report on stained and painted glass  
and leaded glazing

© Jonathan and Ruth Cooke  
January 2015

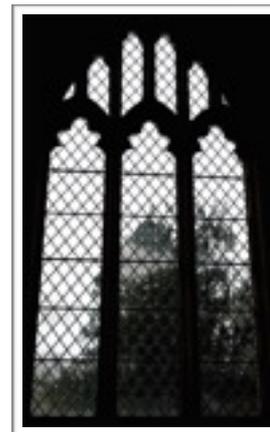
### Tower first floor (west wall)

Sizes Three main lights and six tracery lights, two ?three further eyelets. Perpendicular fenestration. Main lights 480mm x 2550 mm, each in three panels with divisions at 1190 mm and 1980 mm from cill. Traceries not accessed, each in a single panel.  
Leads 8mm convex.  
Bars, all internal, 12 mm diameter, copper tubing, five per light.

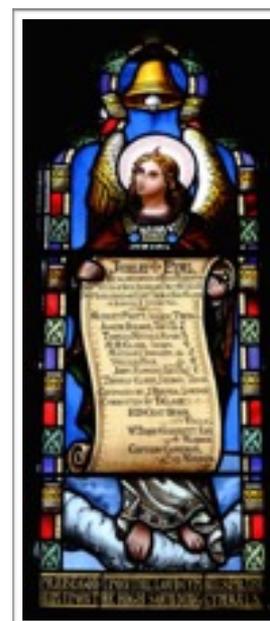
Description Angel standing on cloud holding large scroll commemorating the Jubilee Peal with list of ringers etc. Blue ground. Bell above. At base, stickworked inscription on amber glass: PRAISE GOD UPON THE LOUD CYMBALS:PRAISE/HIM UPON THE HIGH SOUNDING CYMBALS.

Lead matrix	Reasonable
Saddle bars	no evidence of corrosion
Glass and pigments	no significant damage noted to glass. Pigments generally in apparently good condition, though some evidence of minor past damage from condensation settlement in lower part of window, along lead lines.
Dirt and deposits	Some loose dust
Masonry	Painted internally to glass line

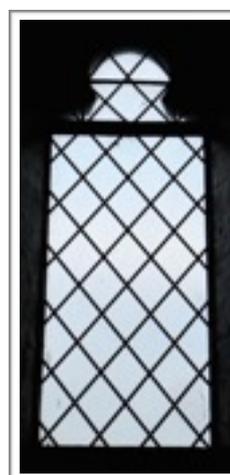
Single light 490 mm x 1380 mm (estimate, based on south wall window) in two panels: now sheet float glazed, with 'decrealed' or similar adhesive lead strip. putty bedded direct into stonework. Rebated opening, with wooden bead.

Probably originally as east wall window, above.
